RETENTION BASIN RESTORATION

Aston Township

Delaware County, PA

September 2014

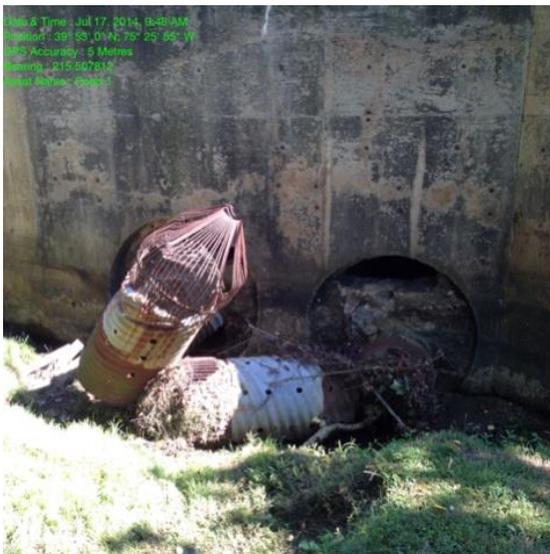
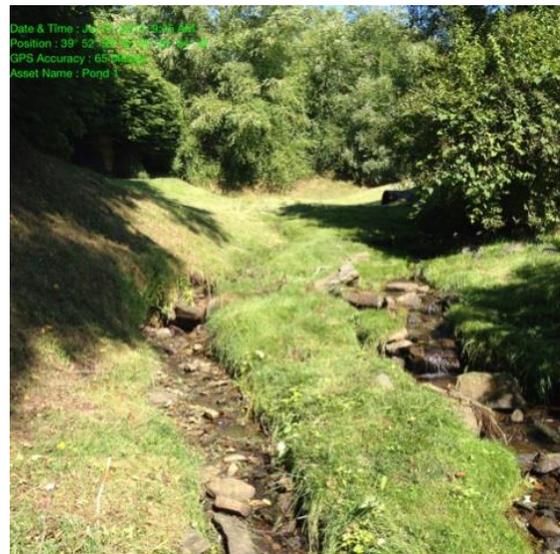
The existing facility, located west of the intersection of Glendale Boulevard and East Dublin Way, can be characterized as in overall poor condition. The existing facility appears to be short circuiting (conveyance of flow from an inlet directly to the principal spillway without adequate detention time for treatment) due to severe erosion and channelization that has occurred in the facility. These channels may be classified as perennial streams due to the presence of significant baseflow that exists (see photo 2). Additional permitting will be required from the DEP for projects with recommended improvements to the perennial streams. The outlet structures are in extremely poor condition and have collapsed. These original riser structures are not functioning properly and therefore do not currently provide the intended stormwater management function (see photo 1). During the inspection on July 17, 2014, the basin bottom was observed as very wet with channelization occurring throughout the facility. The facility appeared to be maintained by mowing, however general maintenance and repairs have not been completed recently. It would appear, based upon the inspection, that a portion of the existing facility was retrofitted recently located on the upstream end of the facility. The retrofit was completed by placing a small riser structure and diverting flood flows around this new water quality improvement. However, this small water quality retrofit improvement has failed due to silt deposition, significant baseflow and invasive plant overgrowth.

The recommendation is to provide a complete stormwater management retrofit of the existing facility. The retrofitted facility would provide both water quality and quantity management at much higher levels than what is currently being provided in the existing facility. Since the

existing riser structures have failed and significant channel erosion and baseflow exists in the facility, very little quality and quantity control is currently being provided. Furthermore the original design was only intended to provide water quantity management and the existing facility would be brought to current standards that meet the NPDES permit requirements.

The recommendation is to convert the existing facility into a multi-step extended detention pond/wetland system. The system would contain a new riser with a low flow extended detention orifice and approximately four (4) separate wetland/detention pools that contain forebays and drop structures to eliminate erosion. Improvements to the previously retrofitted water quality portion would consist of converting the existing system by removal of invasive species and silt deposition. Significant water quality and quantity benefits could be obtained with this type of retrofitted facility and make substantial gains towards meeting the NPDES MS4 permit requirements (see exhibit 2 for example of proposed retrofit). Final improvements to the basin would be to restore the natural landscape with the use of native species in order to increase infiltration, evapotranspiration and recharge. The native herbaceous materials often require less intensive maintenances efforts and will be selected because they are customarily strong growers with a stronger and denser root and stem systems that do not require chemical treatment.

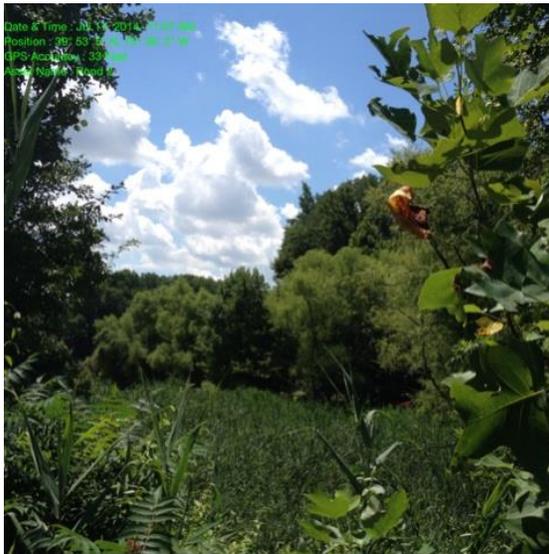
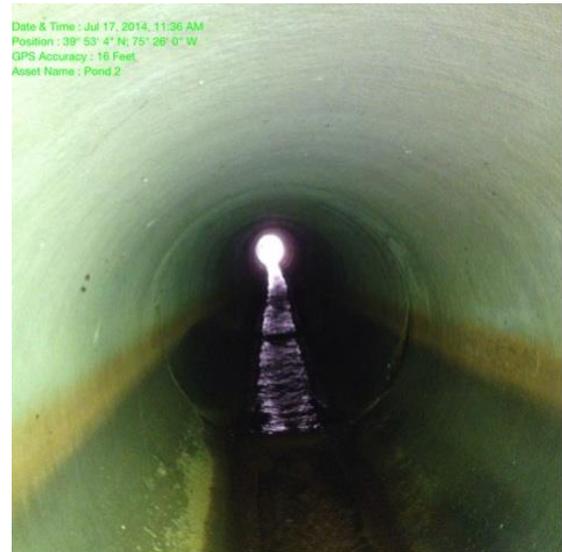
The existing facility is located at the east corner of the intersection of West Dublin Way and East Dublin Way. The existing stormwater basin is functioning as an extended detention pond with a moderate amount of continuous base flow. The facility is approximately 1-acre in size and is heavily vegetated with various species of vegetation (see photo 1). The perimeter fencing is in good condition and does an adequate job of deterring pedestrians from entering the basin. During a preliminary inspection on July 17, 2014, the basin appeared to be functioning adequately with the presence of a base flow condition visible at the riser structure and at the outfall endwall (see photo 2). We recommend that there be a subsequent inspection during a heavy rain event to verify that the basin is functioning correctly during high flow/peak conditions. It was observed that the basin bottom was very wet and had no maintenance access to the basin bottom or the riser outfall structure. The facility appeared to be maintained by mowing on the perimeter bench; however general clearing and grubbing have not been completed recently.

The recommendation is to eradicate all invasive species throughout the basin and to construct a maintenance access to provide clear access to the bottom of the basin, riser structure, forebays and the outfall. We also recommend that a draw-down device (see exhibit 3) be installed and attached to the existing outfall riser structure to provide both water quality and quantity management at higher levels than what is currently being provided in the existing facility. The addition of a draw down device will need to be investigated further and pond routing computations may be required to confirm that additional storage can be provided. The draw down device will also provide a better protection from debris and clogging, enhancing the

maintenance capacity. Additional improvements would include forebays at the pipe inflows which will offer further protection from erosion and improve maintenance activities thereby providing substantial gains towards meeting the NPDES MS4 permit requirements. Based upon funding and the basins capacity, the basin could potentially be converted into a wet extended detention pond. By converting the facility at a later date, if capacity exists, additional water quality benefits might be obtained which will provide gains towards meeting the NPDES MS4 permit requirements.

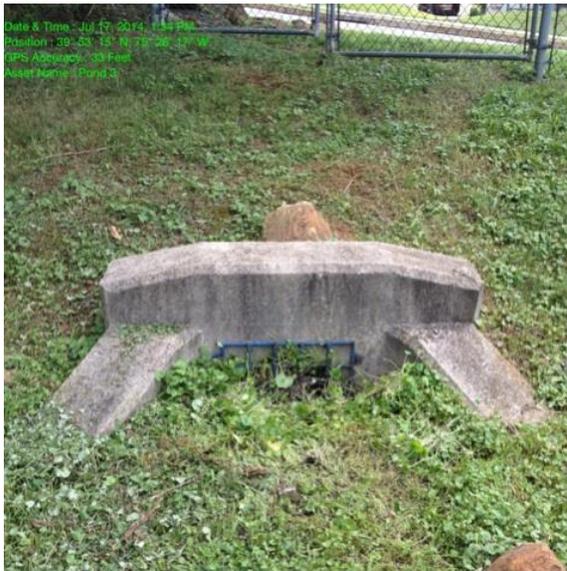
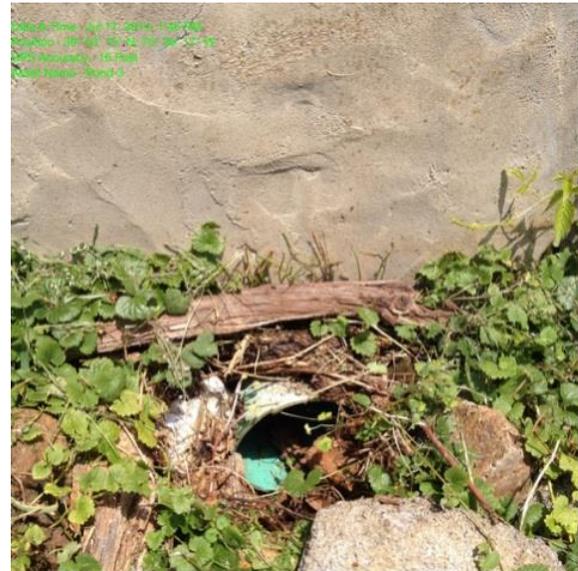
The existing facility is located on the Northern side of Dudonis Lane. The stormwater basin is functioning as a dry extended detention pond. The size of the basin is approximately 5000 square feet and is currently being mowed with no large sized vegetation present within the basin. Due to silt deposition the endwall discharging into the basin has become clogged at the outlet (see photo 1). The riser structure has an existing low flow orifice (see photo 2) that has become clogged with branches, stones, trash and overgrown vegetation; however the basin is generally in good condition. The perimeter fencing is in good condition and does an adequate job of deterring pedestrians from entering the basin. During a preliminary inspection on July 17, 2014 the basin appeared to be functioning properly. We recommend that there be a follow up inspection during a heavy storm event to verify that the basin is functioning correctly during storm event peak conditions.

The recommendation is to clean all debris and silt deposition from the endwall inflow discharge pipe area, remove the “animal screen” from the endwall and to install a forebay at the discharge area. These recommendations will help prevent further silt deposition, clogging and provide additional water quality management. Further upgrades should be made to the riser structure to ensure no future clogging. Our recommendation for the riser structure is to install a horizontal draw-down device (see exhibit 3) to the existing low flow orifice thereby potentially increase the water quality control capacity. Native species shall be planted within the basin in order to increase infiltration, evapotranspiration and recharge. The native herbaceous materials often require less intensive maintenances efforts and will be selected because they are customarily

strong growers with a stronger and denser root and stem systems that do not require chemical treatment.

Additional improvements include the installation of landforms/baffles to reduce short circuit flows during storm events (conveyance of flow from an inlet directly to the principal spillway without adequate detention time for treatment).

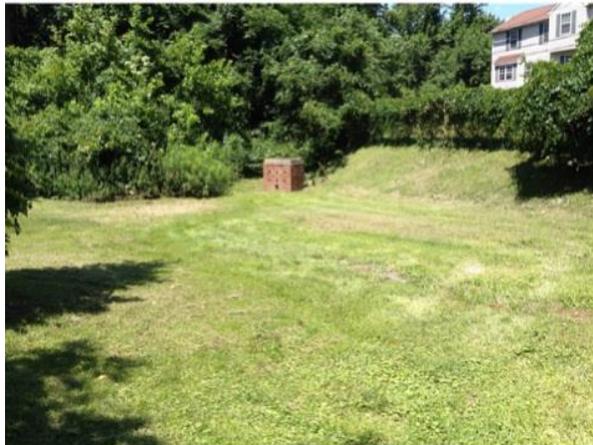
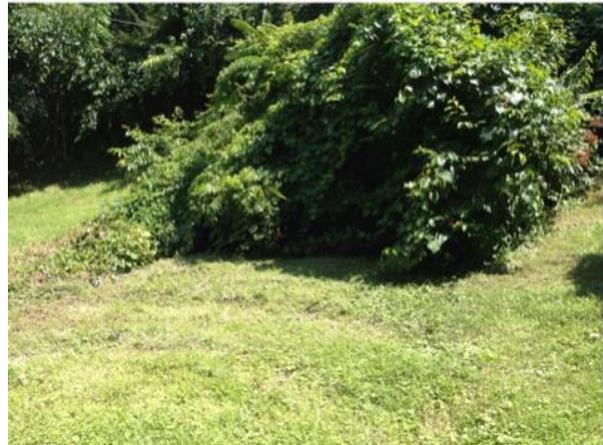
The existing facility is located at the northwest corner at the intersection of Legion Road and Old Pennell Road. The stormwater basin is functioning as a dry extended detention pond and appears to be in good functioning condition. The size of the basin is approximately 13,200 square feet and is currently being mowed. The endwall discharging to the basin has become overgrown with vegetation (see photo 2). The riser structure appears to be in good condition and during the inspection there were no signs of clogging. The perimeter fencing is in fair condition and the access gate has become overgrown with vegetation. It appears that the basin has been accessed through a damaged or altered section that maybe more convenient for the maintenance personnel. During a preliminary inspection on July 17, 2014, the basin appeared to be functioning properly, however we recommend that there be a subsequent inspection during a storm event to verify that the basin is functioning correctly during peak flow conditions.

The recommendation is to clear all heavy vegetation from the basin area including the endwall discharging into the basin and to install forebays. This installation will offer further protection from erosion and improve maintenance activities thereby providing substantial gains towards meeting the NPDES MS4 permit requirements. Further upgrades should be made to the riser structure to ensure no future clogging. Our recommendation for the riser structure is to install a draw-down device (see exhibit 3) to the existing low flow orifice to prevent clogging and to potentially increase the water quality control. Additional improvements would consist of

possible earthen berms and baffles to reduce short circuiting (conveyance of flow from an inlet directly to the principal spillway without adequate detention time for treatment).

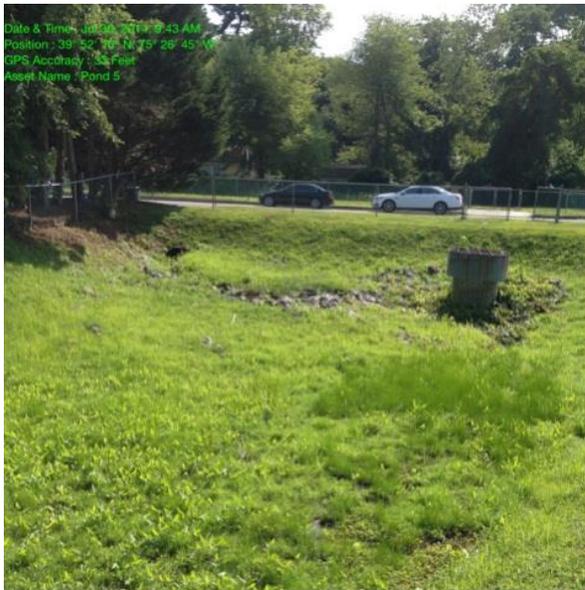
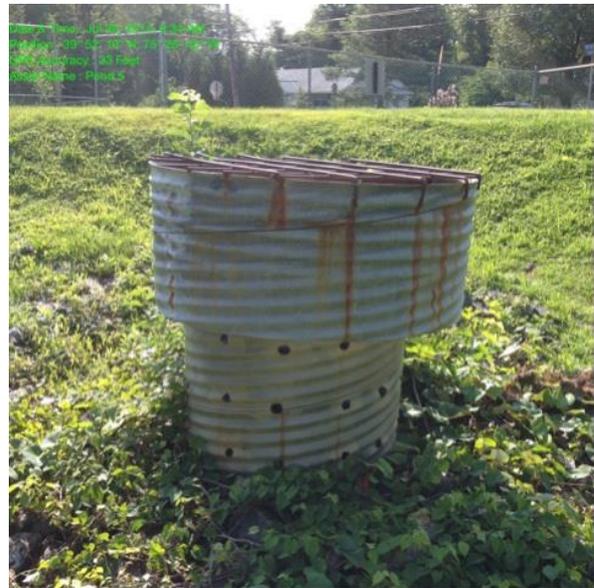
The existing facility is located at the northwest corner of the intersection of Sunnybank Lane and Tyrens Road. The existing stormwater basin is functioning as a dry extended detention pond. The size of the facility is approximately 7,500 square feet and is currently being mowed (see photo 1). The perimeter fencing is in good condition and does an adequate job of deterring pedestrians from entering the basin. During a preliminary inspection on July 17, 2014, the basin appeared to be functioning properly; however the basin bottom was observed to be very wet. At the time of inspection there was evidence of short circuiting of storm flows (conveyance of flow from an inlet directly to the principal spillway without adequate detention time for treatment) and there appeared to be vegetation starting to overgrow the riser structure (see photo 2). The riser was observed to have 1-foot of standing water in the bottom of the structure. As seen in photo 2, the riser structure has a trash rack however the entire structure and trash rack are visually unattractive and the track rack is not securely welded to the structure. We recommend that there be a subsequent inspection during a heavy rain event to verify that the basin is functioning correctly during high flow/peak event conditions.

The recommendation is to construct a forebay with the possible addition of earthen berm baffles to reduce short circuiting and silt deposition within the basin. The existing riser structure should be replaced with a concrete riser of adequate size and properly designed orifices. We also recommend that a horizontal draw-down device (see exhibit 3) be installed and attached to the outfall riser structure to provide both water quality and quantity management at higher levels than what is currently being provided in the existing facility. The addition of a draw down

device will require further investigation and pond routing computations to confirm that additional storage can be provided. The draw down device will also provide a better protection from debris and clogging, enhancing the maintenance capacity. Additional improvements would include the installation of a forebay to accept overland runoff from the west which will offer further protection from erosion and improve maintenance activities thereby providing substantial gains towards meeting the NPDES MS4 permit requirements. Additionally, a small pipe on the East side of the facility appears to have been added as a retrofit. This pipe, inlet and outfall appear to be clogged with sediment and we recommend a new system with a forebay be added at this location. This improvement will increase water quality treatment and reduce erosion potential.

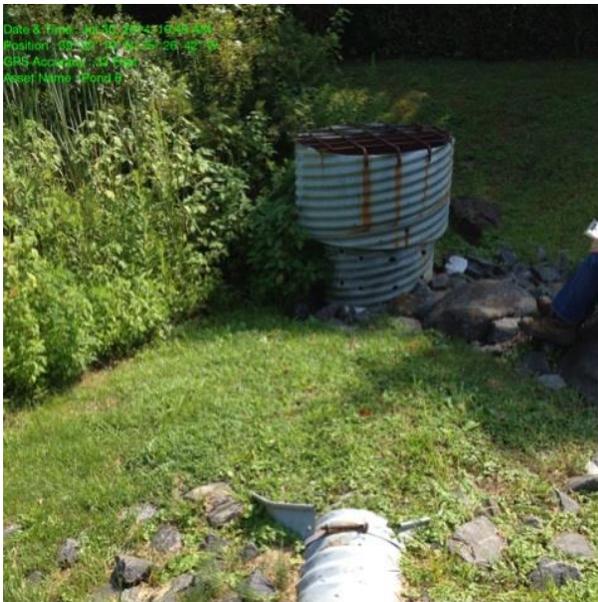
Photo 1

The existing facility is located at the northeast corner of the intersection of Sunnybank Lane and Tyrens Road. The existing stormwater basin appears to have been designed to function as a dry extended detention pond. The size of the facility is approximately 6,500 square feet and is currently being mowed along the perimeter of the basin. The perimeter fencing is in good condition and does an adequate job of deterring pedestrians from entering the basin. During a preliminary inspection on July 17, 2014, the basin appeared to be functioning properly; however the basin bottom was observed to be very wet. The basin is overgrown with Cattails, Phragmites and other plant species. At the time of inspection there was evidence of short circuiting of storm flows (conveyance of flow from an inlet directly to the principal spillway without adequate detention time for treatment) and there appeared to be vegetation starting to overgrow the riser structure (see photo 1). The inflow has become clogged with silt deposition and is an inadequate conveyance system for stormwater runoff (see photo 2). The location of said inflow is less than ideal as it is located within close proximity of the outfall structure and thus promotes short circuiting. As seen in photo 1, the riser structure has a trash rack however, the entire structure and trash rack are visually unattractive and the trash rack is not securely welded to the structure. We recommend that there be a subsequent inspection during a heavy rain event to verify that the basin is functioning correctly during high flow/peak event conditions.

The recommendation is to construct a forebay with the possible addition of earthen berm baffles to reduce short circuiting and silt deposition within the basin. The silt deposits in and around the

inflows must be removed and re-graded. The inflow closest to the outfall structure (photo 1) shall be relocated to a more appropriate location within the basin to allow for the proper discharge into the basin. The alternative to relocating the pipe would be to install baffles to circulate the discharge throughout the basin and therefore will further reduce the possibility of any short circuiting. The existing riser structure should be replaced with a concrete riser of adequate size and properly designed orifices. The inflow on the north end of the basin should be cleared of any vegetation. The white PVC yard drain on the north side of the basin should be removed because it is exposed and will cause further erosion and sediment build-up within the basin. Additional improvements would include removing any invasive species within the basin to reduce the future overgrowth of unwanted vegetation. In conclusion, the installation of forebays, baffles and a properly sized outfall structure will offer protection from erosion and improve maintenance activities thereby providing substantial gains towards meeting the NPDES MS4 permit requirements.

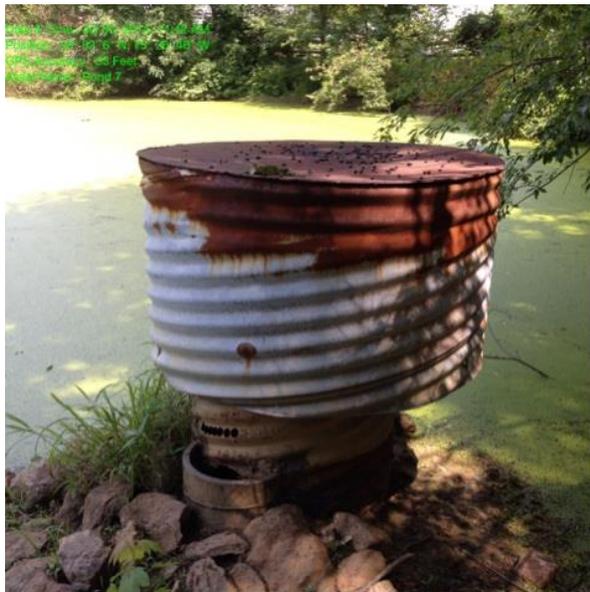
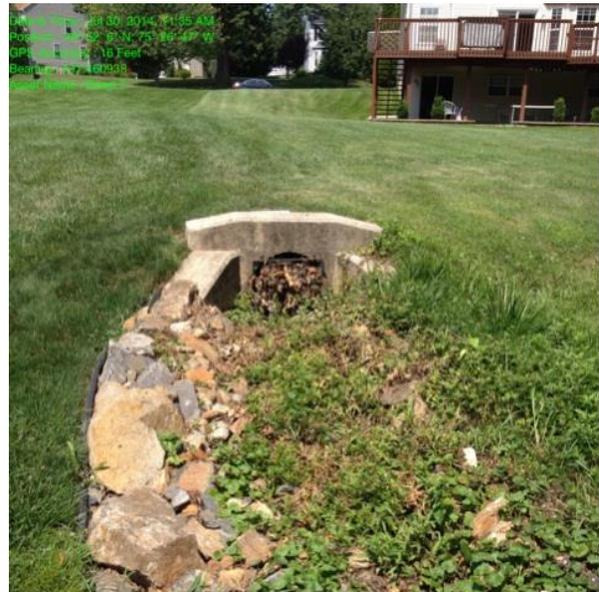
The existing facility can be accessed from behind the properties along the east side of the cul-de-sac along East Evans Way. The existing stormwater basin appears to have been designed to function as a wet extended detention pond. The size of the facility is approximately 19,400 square feet and is currently being mowed along the perimeter of the pond. The perimeter fencing is in fair to poor condition, but appears to do an adequate job of deterring pedestrians from entering the basin. During a preliminary inspection on July 30, 2014, the basin appeared to be functioning as previously altered. There were various weeds and plantings along the perimeter of the pond including a large amount of poison ivy. The inflow has not been maintained and the child-proof rack attached to the headwall has become clogged with debris and leaves. The rip-rap at the discharge point of the inflow has become overgrown with weeds, vines and silt deposition was observed (see photo 2). The ponded water within the basin is covered with algae and there is no aeration within the basin. The riser structure appears to be functioning, however it has become extremely rusted and there are multiple holes near the base of the structure (previously altered) (see photo 1). The riser structure has obvious evidence of degradation and is visually unattractive to the nearby residents. During the inspection, there was a small discharge pipe located at the gate to the basin. It appeared that the pipe was discharging from the adjacent resident's property. Due to the poor location of the drain pipe, it poses as a potential tripping hazard as well as a potential illicit discharge source. We recommend that there be a subsequent inspection during a heavy rain event to verify that the basin is functioning correctly during high flow/peak event conditions and observe other noted deficiencies.

The recommendation is to install a new riser structure and design and construct a safety bench around the wetted perimeter within the basin. Additionally, we recommend that forebays be installed at all inflows present at the site. The silt deposits in and around the inflows must be removed and the headwalls must be maintained properly in the future. The inflow near the southwest entrance to the basin should be re-graded and maintained. Additionally, the inflow near the northwest corner of the basin should have all vegetation removed from the discharge area. The yard drain pipe located at the entrance to the basin should be removed or relocated to a more practical location and determined if illicit discharges exist. It is highly recommended that some form of aeration device be installed within the basin to prevent algae growth and other anaerobic microbes. Additional improvements would include removing any invasive species within the basin to reduce the future overgrowth of unwanted vegetation. In conclusion, the installation of an aeration device, forebays, a safety bench and a properly sized outfall structure will offer additional safety and water quality while improve maintenance activities, thereby providing substantial gains towards meeting the NPDES MS4 permit requirements.

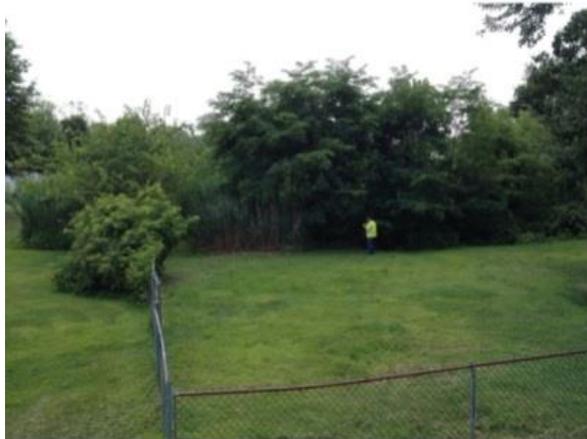
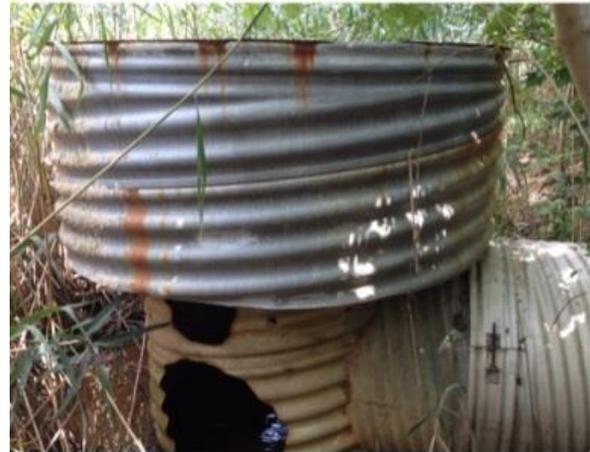
The existing facility is located behind the properties along Crestview Lane and Gettysburg Drive. The existing stormwater basin is functioning as a large or regional extended detention facility with a moderate amount of continuous base flow. The facility is approximately 1-acre in size and is heavily vegetated with various species of vegetation (see photo 1). The perimeter fencing is in good condition and does an adequate job of deterring pedestrians from entering the basin. It should be noted that residents have planted a garden and are accessing area through the perimeter fenced area in the North West corner. During a preliminary inspection on July 30, 2014, the basin appeared to be functioning adequately with the presence of a base flow condition visible at the riser structure (see photo 2). The riser structure had a large diameter low flow orifice, which allowed the base flow to bypass the facility without any attenuation (conveyance of flow from an inlet directly to the principal spillway without adequate detention time for treatment) within basin. It was observed that the basin bottom was very wet and had no maintenance access to the basin bottom or the riser outfall structure. The facility could potentially be classified as a high hazard dam and the dam area is currently only being partially maintained. The facility is being mowed on the perimeter bench; however general clearing and grubbing have not been completed recently. It was observed that various locations along the perimeter, including the dam, have evidence of erosion, holes and gullies.

The recommendation is to eradicate all invasive species throughout the basin and to construct a maintenance access to provide clear access to the bottom of the basin, riser structure, forebays and the outfall. We also recommend that a draw-down device (see exhibit 3) be installed and

attached to the existing outfall riser structure to provide both water quality and quantity management at higher levels than what is currently being provided in the existing facility. The addition of a draw down device will need to be investigated further and pond routing computations may be required to confirm that additional storage can be provided. The draw down device will also provide a better protection from debris and clogging, enhancing the maintenance capacity. Additional improvements would include forebays at the pipe inflows which will offer further protection from erosion and improve maintenance activities thereby providing substantial gains towards meeting the NPDES MS4 permit requirements. We also recommend that there be a subsequent inspection including a geotechnical evaluation of the facility including the dam area, outfall pipe and structure. Additional inspections during a heavy rain event may be necessary to verify that the basin is functioning correctly during high flow/peak conditions. There is potential loss of life associated with the failure of this dam during a storm event. Several homes exist directly down stream of this facility. The outfall pipe (appears to approximately 60" diameter) is placed between two residential homes. This outfall pipe doesn't appear to be encased in concrete and the condition is unknown. We recommend a full geotechnical inspection of the outfall system be completed.

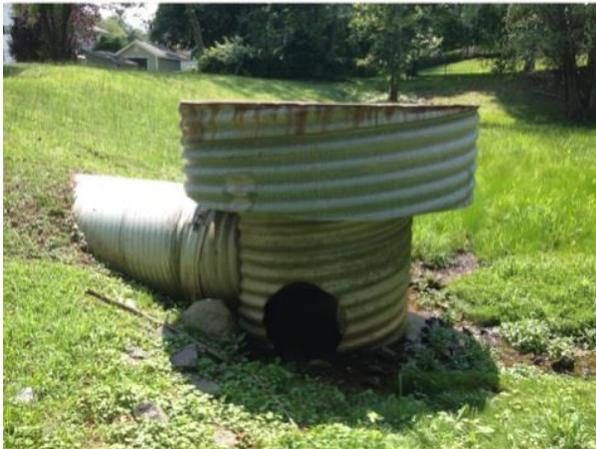
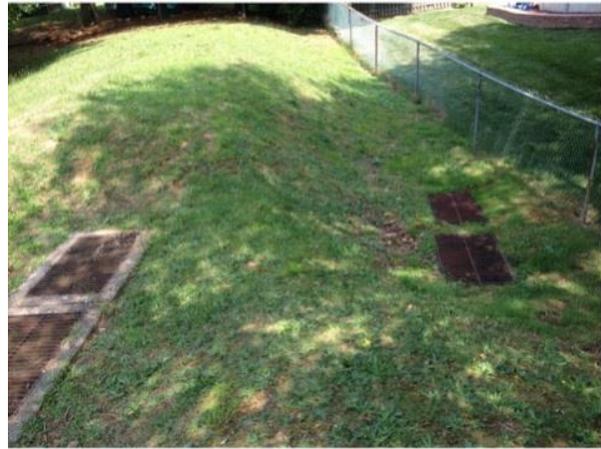
The existing facility is located west of the intersection of Crestview Lane and Gettysburg Drive. The size of the facility is approximately 17,400 square feet and appears to have regular maintenance and mowing. The perimeter fencing is in good condition and does an adequate job of deterring pedestrians from entering the basin. The existing facility appears to be short circuiting (conveyance of flow from an inlet directly to the principal spillway without adequate detention time for treatment) due to erosion and channelization that has occurred within the facility. These channels may be classified as perennial streams due to the presence of significant baseflow that exists. Additional permitting will be required from the DEP for projects with recommended improvements to the perennial streams. The outlet structure appears to be allowing the baseflow to pass without attenuation and could be considered visually unattractive. The basin has incorporated good environmental features and with the exception of the baseflow short circuiting, the basin appears to be in overall good condition. The emergency spillway is unique in that it is piped with the use of inlets at the top and bottom of the dam/berm and further inspections should be done to confirm that adequate capacity exists during large storm events. Basin No. 8 appears to drain directly into this basin, so further analysis is recommended to confirm that adequate volume and capacity is being provided within the basin(s). During the inspection on July 30, 2014, the basin bottom was observed as very wet with channelization/erosion occurring throughout the facility.

The recommendation is to replace the existing riser structure with one of adequate sized and properly designed orifices to prevent future short circuiting within the basin. The outfall structure shall have a draw-down device (see exhibit 3) attached, to provide both water quality and quantity management at higher levels than what is currently being provided in the existing facility. Additional improvements to the basin consist of restoring the natural landscape with the use of native species in order to increase infiltration, evapotranspiration and recharge. The native herbaceous materials often require less intensive maintenances efforts and will be selected because they are customarily strong growers with a stronger and denser root and stem systems that do not require chemical treatment. Significant water quality and quantity benefits could be obtained with the recommended improvements to the facility and make substantial gains towards meeting the NPDES MS4 permit requirements.

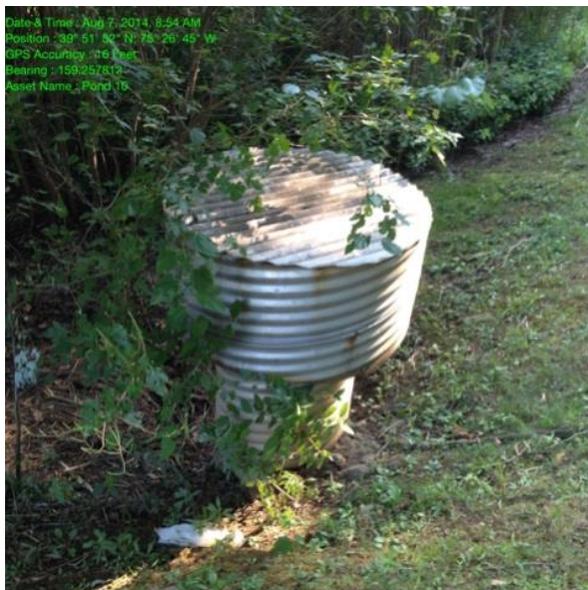
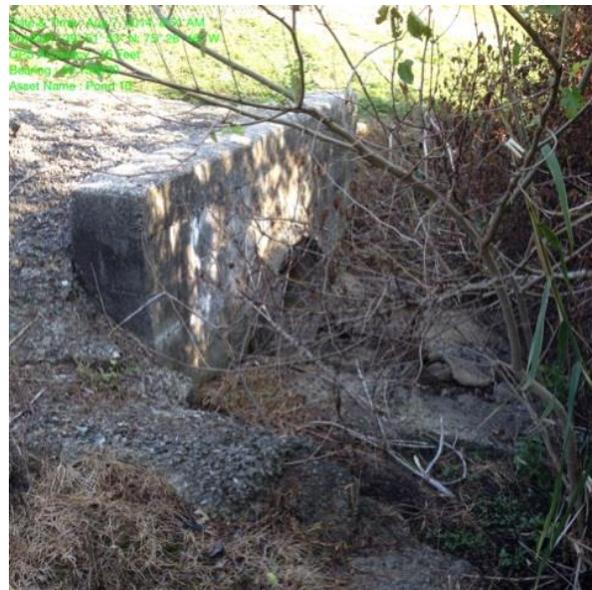
The existing facility is located along the south side of Scott Lane. The existing stormwater basin appears to have been designed to function as a dry extended detention pond. The size of the facility is approximately 26,600 square feet and is currently being mowed along the perimeter of the basin. The perimeter fencing is in good condition and does an adequate job of deterring pedestrians from entering the basin. During a preliminary inspection on August 7, 2014, the basin appeared to be functioning properly; however the basin bottom was observed to be very wet and overgrown with Phragmites and other plant species. At the time of inspection there was evidence of short circuiting of storm flows (conveyance of flow from an inlet directly to the principal spillway without adequate detention time for treatment). There also appeared to be vegetation starting to overgrow the riser structure (see photo 1). The inflow appears to be structurally stable; however, there is an abundance of vegetation within close proximity to the structure (see photo 2). As seen in photo 1, the riser structure has a trash rack however the entire structure and trash rack are visually unattractive and the trash rack is not securely welded to the structure. Yard drains discharging into the basin showed evidence of erosion within the discharge area. We recommend that there be a subsequent inspection during a heavy rain event to verify that the basin is functioning correctly during high flow/peak event conditions.

The recommendation is to construct a forebay with the possible addition of earthen berm baffles to reduce short circuiting and silt deposition within the basin. All invasive vegetation should be removed from the basin and replaced with native species. We recommend restoring the natural landscape with the use of native species in order to increase infiltration, evapotranspiration and recharge. The native herbaceous materials often require less intensive maintenances efforts and will be selected because they are customarily strong growers with a stronger and denser root and stem systems that do not require chemical treatment.

The existing riser structure should be replaced with a multistage concrete principal spillway of adequate size and properly designed orifices to control multiple storm events. The inflow on the northwest end of the basin should be cleared of any vegetation. The yard drains discharging to the basin should be removed to prevent future erosion and sediment build-up within the basin. The installation of forebays, baffles and a properly sized principal spillway structure will offer improved conveyance and flood control, protection from erosion, enhanced water quality treatment and improve maintenance activities thereby providing substantial gains towards meeting the NPDES MS4 permit requirements. To further enhance pollutant reduction capacity, the basin could be retrofitted to an extended detention shallow wetland facility. The existing hydrology appears to support a wetland system that would offer improved sediment and nutrient removal capacity.

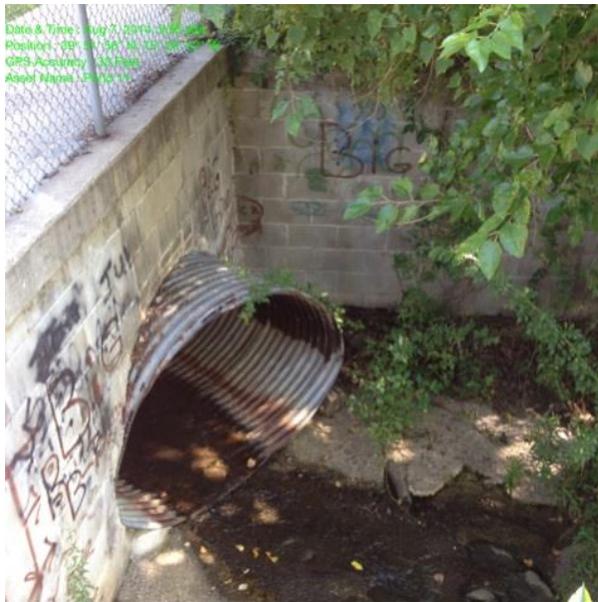
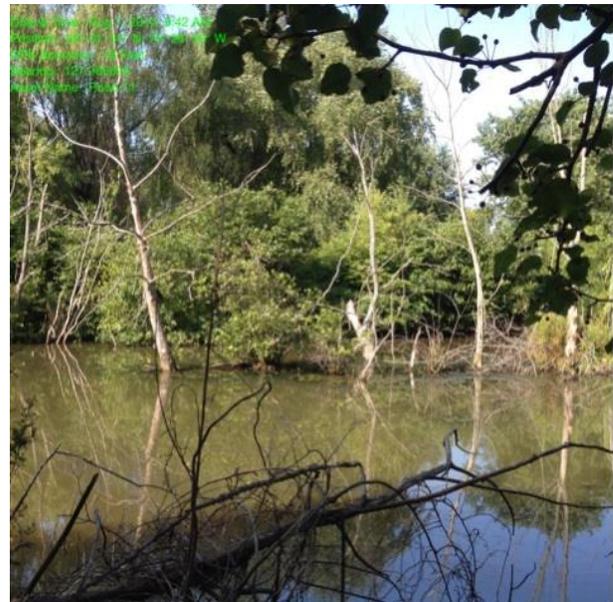
The existing facility can be accessed from behind the properties along the south side of Giles Lane. The existing stormwater basin appears to have been an existing pond that was retrofitted to function as a wet extended detention pond. The size of the facility is approximately 1-Acre and is currently being mowed along the perimeter of the pond; however, there appears to be no safety bench along the water surface perimeter. The fencing is in good condition and does an adequate job of deterring pedestrians from entering the basin. During a preliminary inspection on August 7, 2014, the basin appeared to be functioning properly. The perimeter of the wet pond was heavily vegetated with various plantings including large diameter trees. The inflow has not been maintained, there was vegetation growing along the wingwalls and the structural integrity is possibly compromised. The pond water was observed to be dirty and murky, evidence of erosion and suspended solids. We recommend that there be a subsequent inspection during a heavy rain event to verify that the basin is functioning correctly during high flow/peak event conditions.

The recommendation is to clear all invasive vegetation along with any large diameter trees that would compromise the integrity of the basin. A safety bench is recommended to be constructed around the wetted perimeter of the basin. Additionally, we recommend that all vegetation surrounding the inflow be removed as well as forebays be installed at all inflows present at the site. We also recommend that vegetation be cleared away from the bank near the principal spillway to allow visual inspection and access for maintenance. General maintenance and shrub

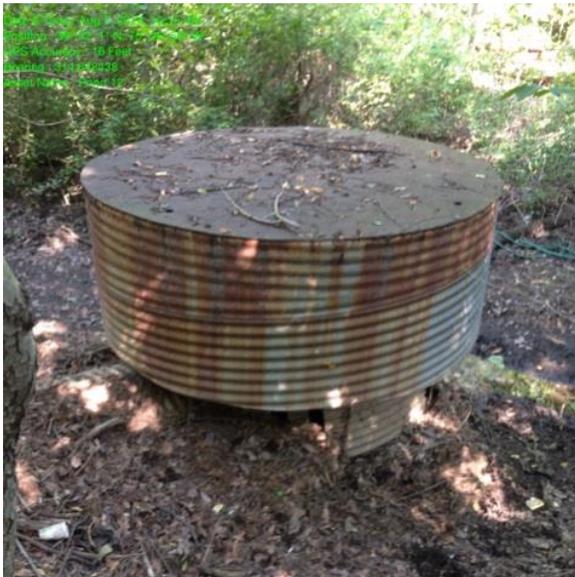
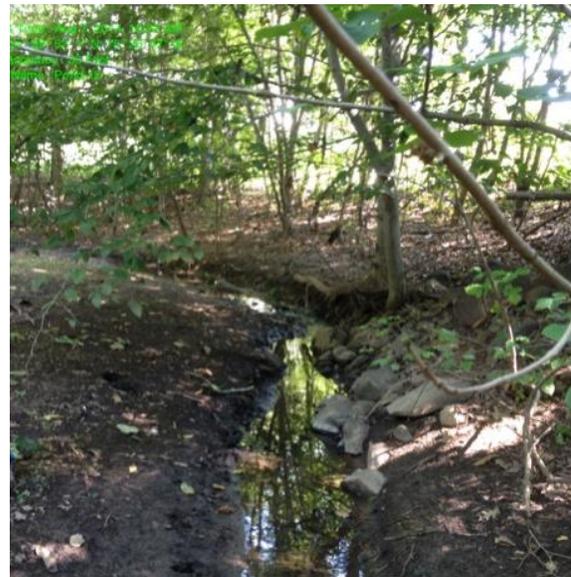
The existing facility can be accessed from the cul-de-sac along West Evans Way. The size of the facility is approximately 38,000 square feet and is heavily wooded with no stabilized grasses within the basin. The existing facility appears to be short circuiting due to severe erosion and channelization that has occurred in the facility. These channels may be classified as perennial streams due to the presence of significant baseflow that exists (see photo 2). Additional permitting will be required from the DEP for projects with recommended improvements to the perennial streams. The outlet structure is in extremely poor condition and has become clogged with silt covering the low flow orifice (see photo 1). During a preliminary inspection on August 7, 2014, the basin appeared to be functioning properly; however the basin bottom was observed to be very wet with channelization occurring throughout the facility. The basin is overgrown with various plantings including large diameter trees. The entire basin bottom was comprised of silt deposits and does not appear to have been maintained or excavated down to the original design depth. The inflow located on the northeast side of the basin appears to be structurally stable; however, there is an abundance of vegetation within close proximity to the structure. As seen in photo 1, the riser structure is visually unattractive and has become extremely degraded. We recommend that there be a subsequent inspection during a heavy rain event to verify that the basin is functioning correctly during high flow/peak event conditions.

The recommendation is to construct forebays at all inlets into the basin. Additionally we recommend the possible addition of earthen berm baffles to reduce short circuiting and silt

deposition within the basin. All invasive vegetation should be removed from the basin including large diameter trees. The existing riser structure should be replaced with a multistage concrete principal spillway of adequate size and properly designed orifices to manage multiple storm events. The inflow on the northeast side of the basin should be cleared of any vegetation. Due to the volume of silt observed in the basin reservoir area and the presence of extensive vegetation, it is likely the basin is not functioning hydraulically as designed, Once the necessary clearing and grubbing has been performed throughout the basin we recommend that a subsequent survey inspection and a hydrologic and hydraulic analysis be performed. The analysis will determine if the basin is hydraulically functioning properly and will indicate if further design is necessary to bring the existing facility up to standards. The installation of forebays, baffles and a properly sized outfall structure will offer protection from erosion, enhanced pollutant removal capacity and improve maintenance activities thereby providing substantial gains towards meeting the NPDES MS4 permit requirements.

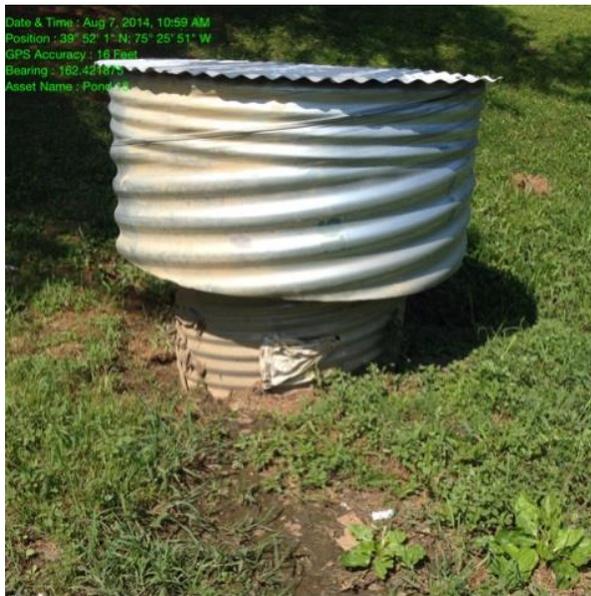
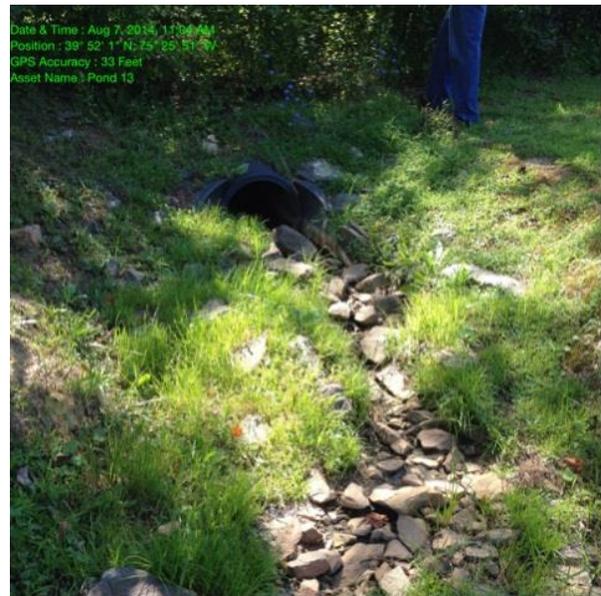
The existing facility is located at the southwest corner of the intersection of Aston Court and Thomas Road. The existing stormwater basin is functioning as a dry extended detention pond. The size of the facility is approximately 10,800 square feet and is currently being mowed. The perimeter fencing is in fair condition with moderate rusting and does an adequate job of deterring pedestrians from entering the basin. During a preliminary inspection on August 7, 2014, the basin appeared to be functioning properly; however the basin bottom appeared to be largely silt depositions. At the time of inspection there was evidence of short circuiting of storm flows (conveyance of flow from an inlet directly to the principal spillway without adequate detention time for treatment) from the northern discharge point. The riser structure appears to be functioning correctly however the entire structure and the anti-vortex trash rack are visually unattractive. The inflow at the southern end of the basin was observed to have ponding at the discharge point. We recommend that there be a subsequent inspection during a heavy rain event to verify that the basin is functioning correctly during high flow/peak event conditions.

The recommendation is to construct forebays at all discharge points into the basin. Additionally, we recommend constructing earthen berm baffles to reduce short circuiting and silt deposition within the basin. The existing riser structure which appears to be a temporary outlet structure that was left in place should be replaced with a multistage concrete principal spillway of

adequate size and properly designed orifices to manage multiple storm events. We also recommend that a horizontal draw-down device (see exhibit 3) be installed and attached to the outfall structure to provide both water quality and quantity management at higher levels than what is currently being provided in the existing facility. The addition of a draw down device will require further investigation and pond routing computations to confirm that additional storage can be provided. The draw down device will also provide a better protection from debris and clogging, enhancing the maintenance capacity. These improvements will increase water quality treatment and reduce erosion potential thereby providing substantial gains towards meeting the NPDES MS4 permit requirements.

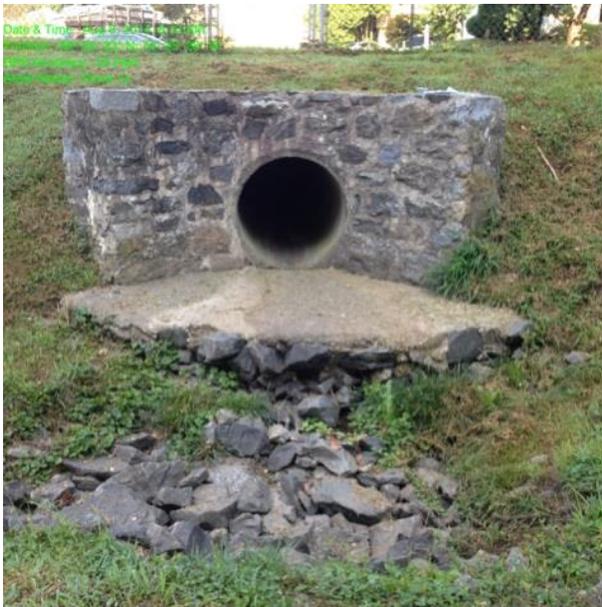
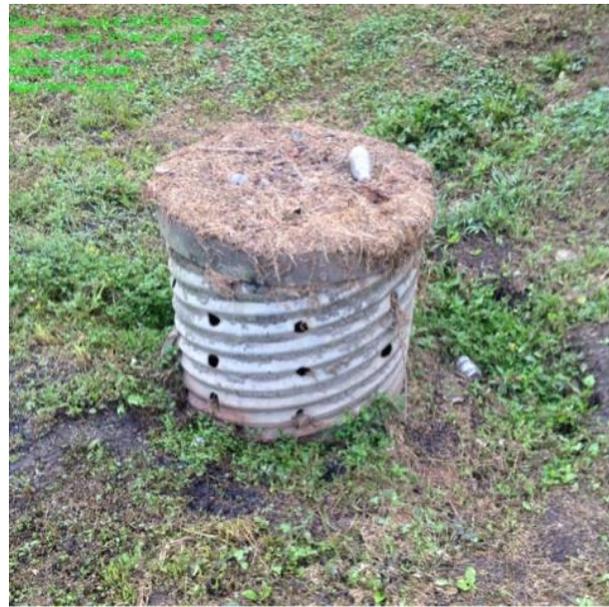
The existing facility is located at the end of the cul-de-sac along Brake Lane. The existing stormwater basin is functioning as a dry extended detention pond. The size of the facility is approximately 7,600 square feet and is currently being mowed. The perimeter fencing is in good condition and does an adequate job of deterring pedestrians from entering the basin. During a preliminary inspection on August 8, 2014, the basin appeared to be functioning properly; however the basin bottom was observed to be very wet. At the time of inspection there was evidence of short circuiting of storm flows (conveyance of flow from an inlet directly to the principal spillway without adequate detention time for treatment) and erosion and channelization occurring on the basin bottom. The riser structure is extremely degraded and is clogged with debris and grass (see photo 2). The discharge area at the inflow appears to function properly however during heavy storms the drop in elevation may cause erosion (see photo 1). There were animal burrows observed within the basin and the embankment. We recommend that there be a subsequent inspection during a heavy rain event to verify that the basin is functioning correctly during high flow/peak event conditions.

The recommendation is to construct a forebay at the inflow to prevent erosion and future degradation of the basin. The existing riser structure should be replaced with a concrete riser of adequate size and properly designed orifices. We also recommend that a horizontal draw-down device (see exhibit 3) be installed and attached to the outfall riser structure to provide both water quality and quantity management at higher levels than what is currently being provided in the

existing facility. The draw down device will also provide a better protection from debris and clogging, enhancing the maintenance capacity. Additional improvements to the basin will include miscellaneous grading to repair various erosion areas and relocating or removing any yard drains to prevent future erosion. The installation of the forebay, draw-down device and a properly sized outfall structure will offer protection from erosion and improve maintenance activities thereby providing substantial gains towards meeting the NPDES MS4 permit requirements.

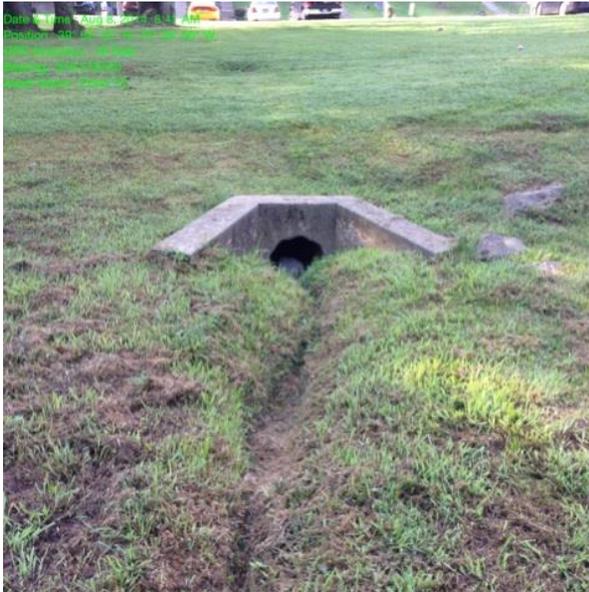
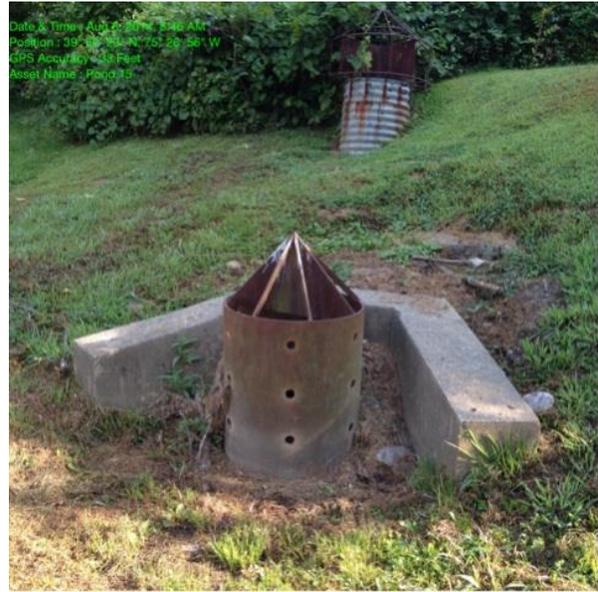
The existing facility is located on the Northeast corner at the intersection of Colonial Way and Penns Court. The stormwater basin is functioning as a dry extended detention pond. The size of the basin is approximately 7,600 square feet and is currently being mowed. The inflow on the southern end of the basin has become overgrown due to silt deposition (see photo 1). The riser structures have become degraded and are visually unattractive (see photo 2). The most northern riser structure has become filled with garbage and debris. It has become apparent that the trash racks do not function properly. During a preliminary inspection on August 8, 2014 the basin appeared to be functioning properly. There is no perimeter fencing and at the time of inspection there were children's toys within the basin. We recommend that there be a follow up inspection during a heavy storm event to verify that the basin is functioning correctly during storm event peak conditions.

The recommendation is to clean all debris and silt deposition from the inflow discharge pipe area, and to install a forebay at the discharge area. These recommendations will help prevent further silt deposition, clogging and provide additional water quality management. Further upgrades should be made to the riser structure to ensure no future clogging. Our recommendation for the riser structure is to replace the existing structure with one of adequate size and to install a horizontal draw-down device (see exhibit 3) to the existing low flow orifice thereby increasing the water quality control capacity. Additional improvements would consist of plantings and possible earthen berm baffles to reduce short circuit flows during storm events.

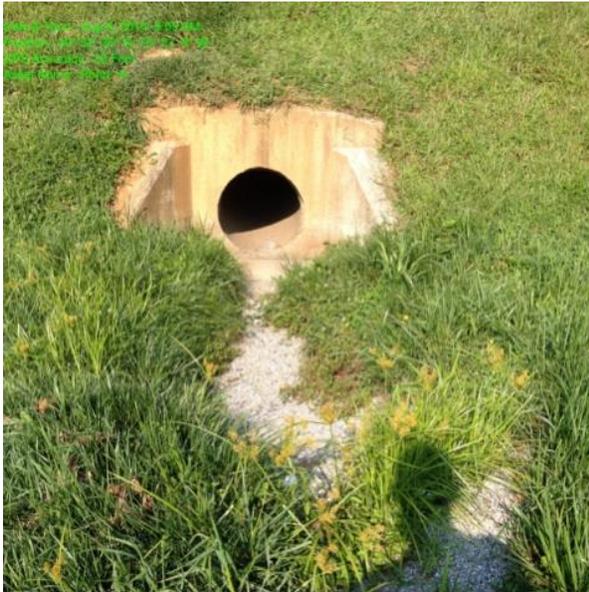
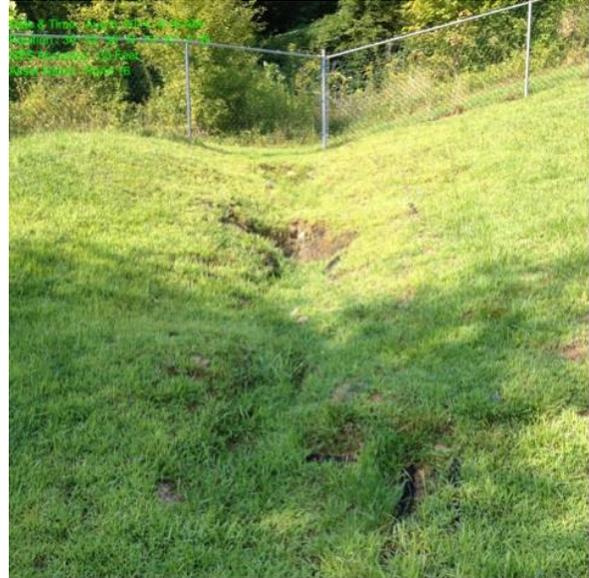
The existing facility is located south of the intersection of Birney Highway and Mclaughlin Drive and can be access from Mclaughlin Drive. The stormwater basin is functioning as a dry extended detention pond and appears to be in good functioning condition. The size of the basin is approximately 23,400 square feet and is currently being mowed and maintained. The endwall discharging to the basin has evidence of minor silt and gravel deposition (see photo 1). The riser structure appears to be in good condition and during the inspection there were no signs of clogging. The perimeter fencing is in good condition. There appears to be minor erosion near the location of the emergency spillway (see photo 2). During a preliminary inspection on August 8, 2014, the basin appeared to be functioning properly, however we recommend that there be a subsequent inspection during a storm event to verify that the basin is functioning correctly during peak flow conditions.

The recommendation is to clear the discharge area of the inflow of all silt and gravel deposits. The area near the emergency spillway should be regarded and stabilized to prevent further erosion. In conclusion the basin appears to be function properly and requires minimal improvements.
